Field testing of copper alloy cages in British Columbia: comparison of measured copper to ambient water quality criteria.

H. E. Gray^{1,3}, L. Gace², R.L. Dwyer², R. C. Santore⁴, J. McGeer¹ and D. S. Smith¹

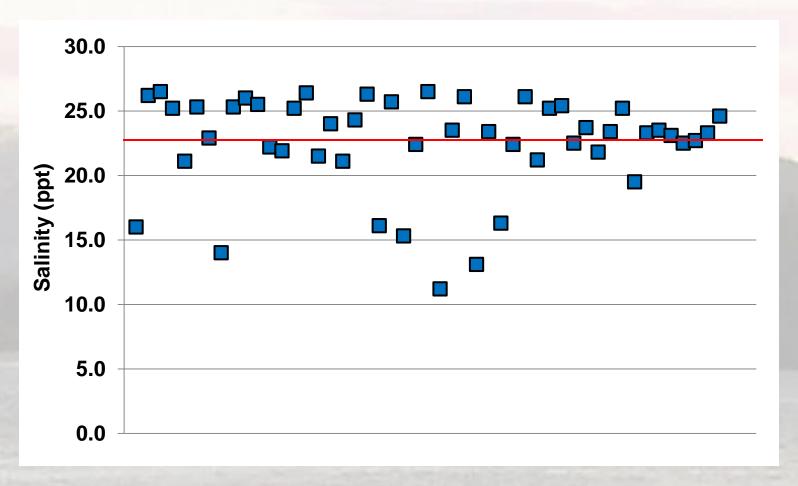
Salinity

$$22.6 \pm 3.8 \text{ ppt}$$

N = 48

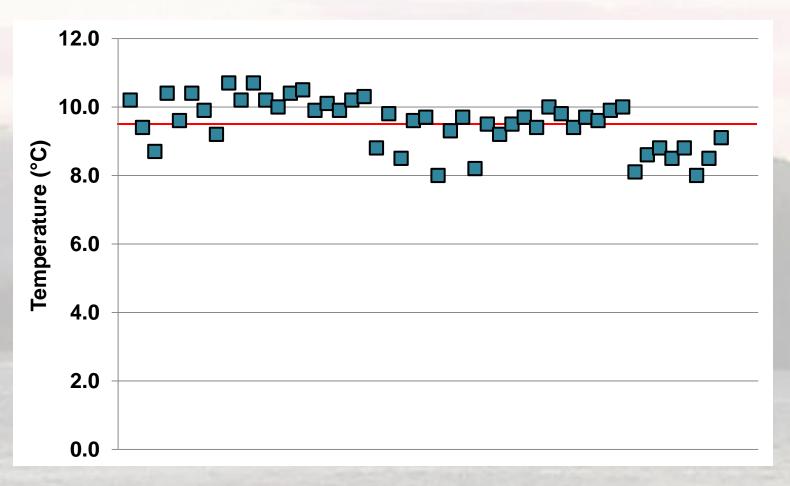
Temperature

$$9.5 \pm 0.7 \,^{\circ}\text{C}$$

N = 48

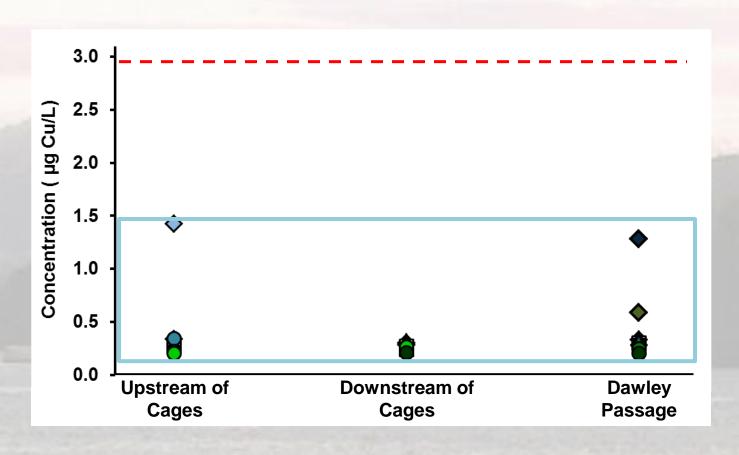
[Cu]_{Total}

- ♦ Day 1 (Nov. 26)
- ◆ Day 2 (Nov. 27)

[Cu]_{Dissolved}

- Day 1 (Nov. 26)
- Day 2 (Nov. 27)

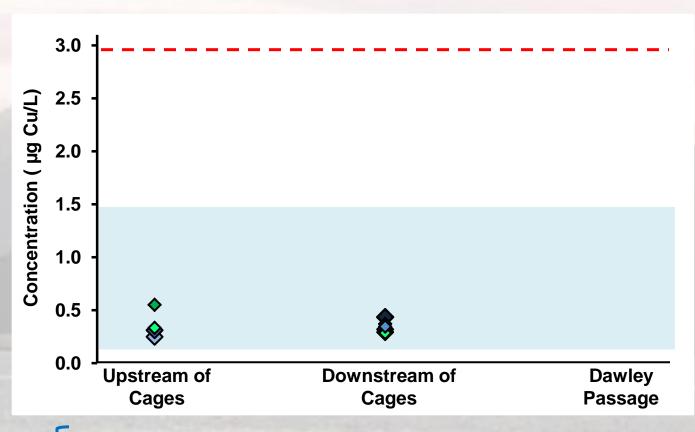
Day 6 and 8 (Dec. 4 and 6)

- Walls of cage was installed Floatation pipes were delivered for cage 1

Floatation device installed Lift bag was removed

Cage 1 in water

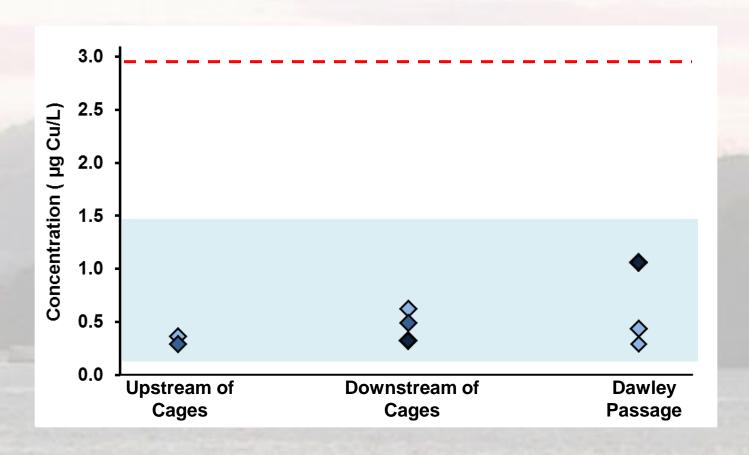
Day 9 (Dec. 7)

- Bottom of Cage 2 installed

Cage 1 in water for 24 hours

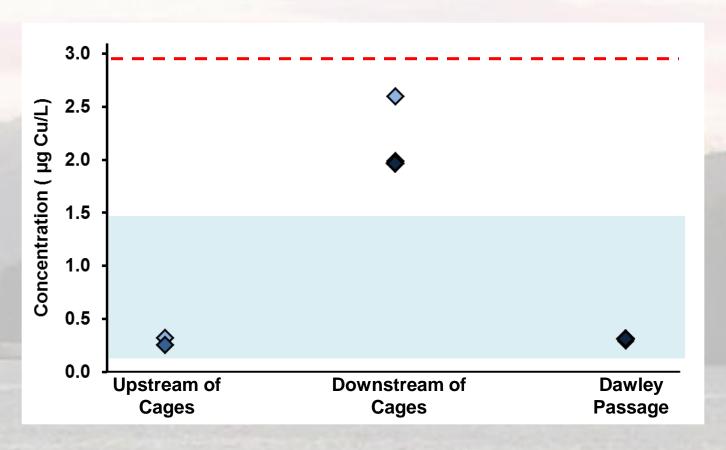
Day 15 (Dec. 13)

- Floatation device installed
- Lift bag was removed

Cage 1 and Cage 2 in water

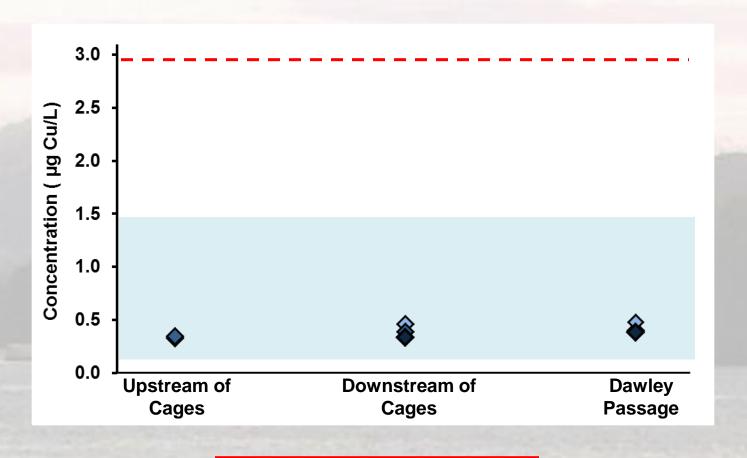
Day 20 (Dec. 18)

Cage 1 and Cage 2 in water for 4 days

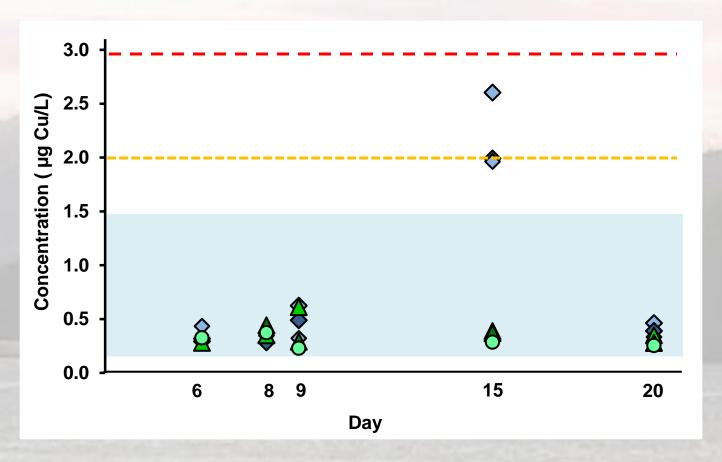
Downstream Samples Over Time

- ◆ [Cu]_{Total}
- [Cu]_{Dissolved}

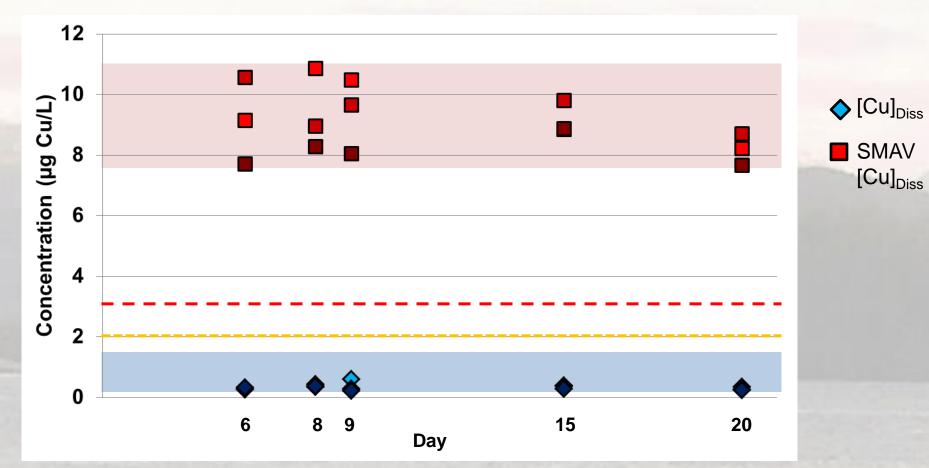
Downstream Dissolved Cu Concentrations

- -Species Mean Acute Value (SMAV)
 - Average of EC50 data
 - -Mytilus edulis
 - -Most sensitive organism in marine database

Measured values are below applicable British Columbian water quality standards for copper.

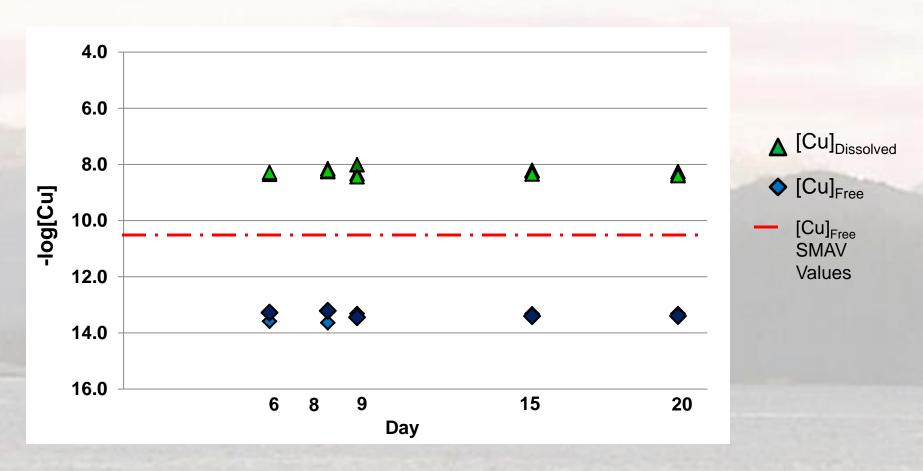
Bioavailable Cu Concentrations

- -Species Mean Acute Value (SMAV)
 - Average of EC50 data
 - -Mytilus edulis
 - -Most sensitive organism in marine database

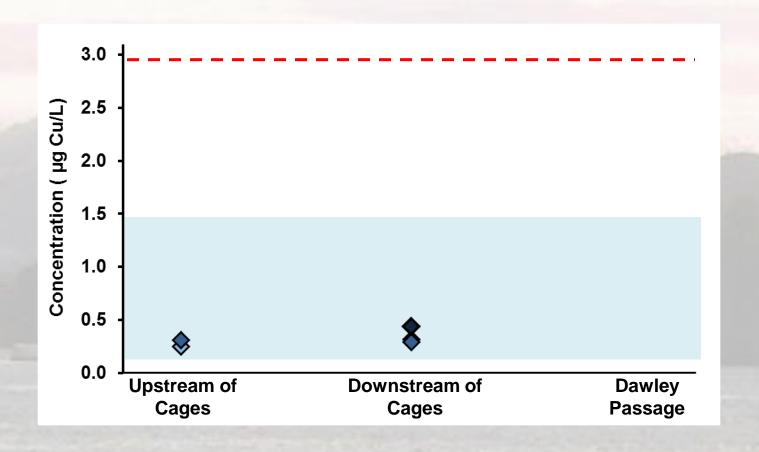
Day 6 and 8 (Dec. 4 and 6)

- Walls of cage was installed
- Floatation pipes were delivered for cage 1

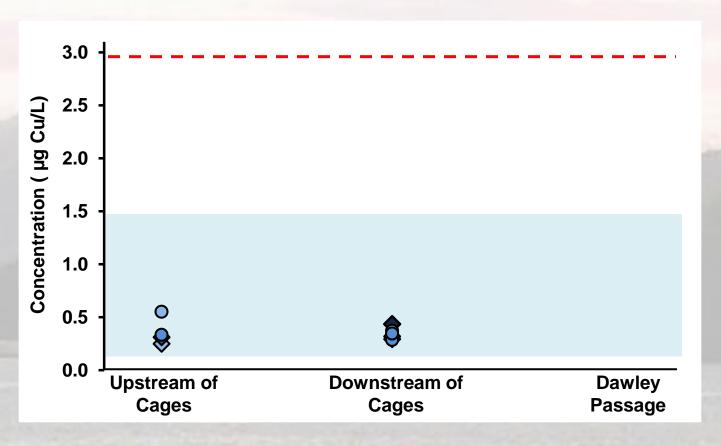
Day 6 and 8 (Dec. 4 and 6)

- Floatation device installed
- Lift bag was removed

Cage 1 in water
